Resurvey of the Boundary Between the United States and Canada from Point Roberts on the 49th Parallel to the Pacific Ocean

by David Steele, PLS Survey Manager for the Washington State Department of Natural Resources

Remeasurement Of The Boundary Between The United States And Canada Forty-ninth Parallel To The Pacific Ocean

by David Steele, PLS, Chief Surveyor, Washington State Department of Natural Resources

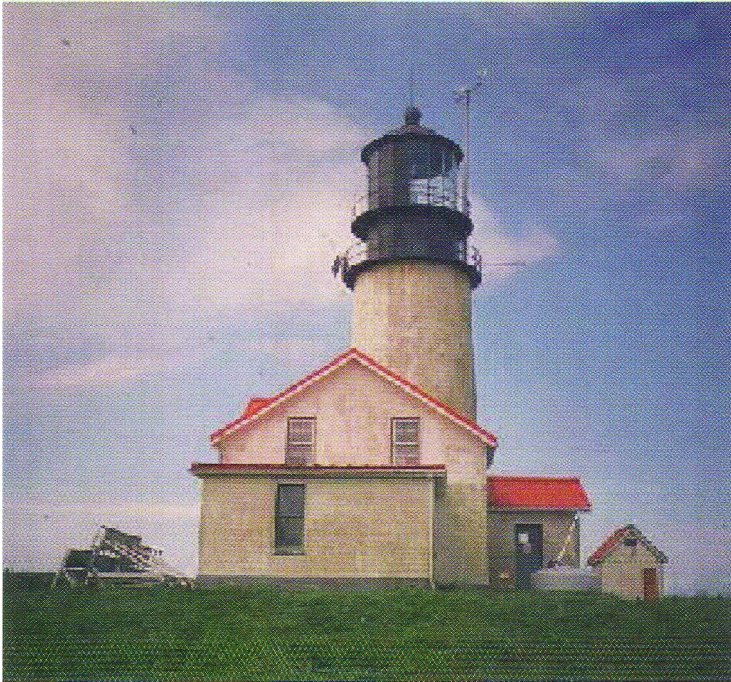
Cape Flattery Lighthouse on Tatoosh Island.

The station is the center of the Cape Flattery Lighthouse. It is white and conical. The base of the tower joins the light keeper's dwellings. The focal plane is 53 feet above the ground and 156.6 feet above mean high water. Above the main platform the housing is metal and 12-sided. The glass has 12 sides also. The elevations were determined by spirit levels run from the water line. A discrepancy was noted in the 1955 recovery where the computed distance to Tatoosh 1886, a control station, is 114.56 meters and the distance given in J.J. Gilbert's original computations is 114.54 meters.

The Tatoosh Island lighthouse, a.k.a. Cape Flattery Lighthouse is the United States reference mark to point 12, the terminus of the International Boundary at the Pacific Ocean. The reference mark is in line with point 12 and Bonilla Point Reference Mark in Canada. It is located on the South side of the entrance to the Juan de Fuca Strait and about 3,000 feet northwest of the northwestern most point of the mainland of Washington State, which is Cape Flattery, Clallam County. The NGS description states that the lighthouse is a white conical tower

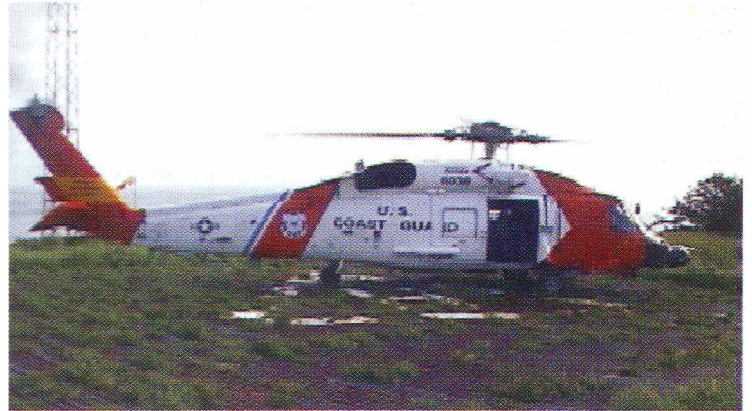
Transportation By U.S.C.G.

A crane jutting from the cliff top would hoist anything coming onto the island. The 75foot lift was quite exciting, but very reliable.

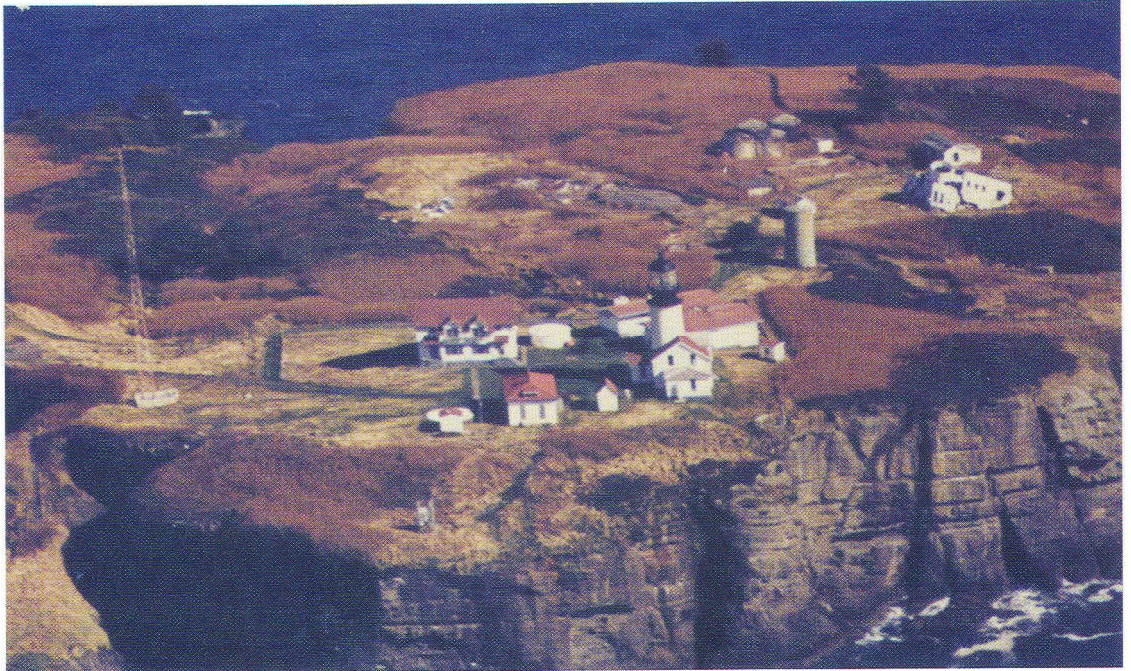
On the DOT aerial photo, shown above, one can see the

many structures, most of which have now been removed. The Weather Bureau is in the back right and is collapsed. The school building in the back, foreground is now gone. The catch basin, in which the Tatoosh Reset is located, is directly beyond the lighthouse and is shown as a circular gray area. A small cemetery is located in the far upper right part of the photo.

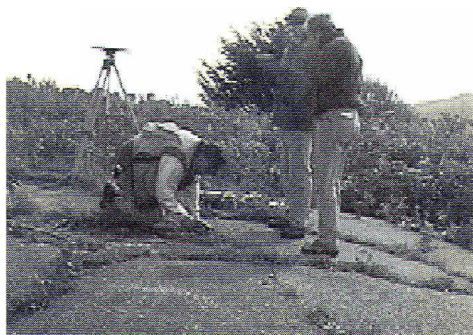
"Tatoosh Reset" at catch basin.

On May 3, 2000, we found the catch basin that had been constructed over the mark as shown on the photo. This catch basin is designed to capture rain as it runs off of the dome surface and into the gutter around the edge. Just don't mind the bird droppings scattered about; that counteracts the acid in the rainwater. The water is then piped into the cistern to the East.

The station's subsurface mark was found in a 6-inch hole in the concrete as described in 1974. We described it as a 1/2-inch copper shaft with a cross on top at 0.25 feet below the surface of a concrete catch basin. Reference Mark No. 1 was recovered, but has been damaged. The brass shank of the mark is left in the broken edge of a concrete octagonal collar around a manhole in the top of a cistern. The cistern is approximately 6 feet tall x 10 feet x 20 feet and the top is about the 5 feet in height below the catch basin. We did not measure to this mark since there is about 75 feet of 15-foot tall dense brush between marks.
